TL-Ultralight s.r.o. Notice of Continued Airworthiness
Service Notification 043012
Inspection of horizontal stabilizer connections

DATE OF NOTICE: 30 April 2012
EFFECTIVE DATE: Immediately
AFFECTED AIRCRAFT: TL-Ultralight, TL2000, StingSport, Sting S3, & Sting S4.
AFFECTED SERIAL NUMBERS: All
NOTICE ID: SN043012
PAGES: This is page 1 of 2 pages.

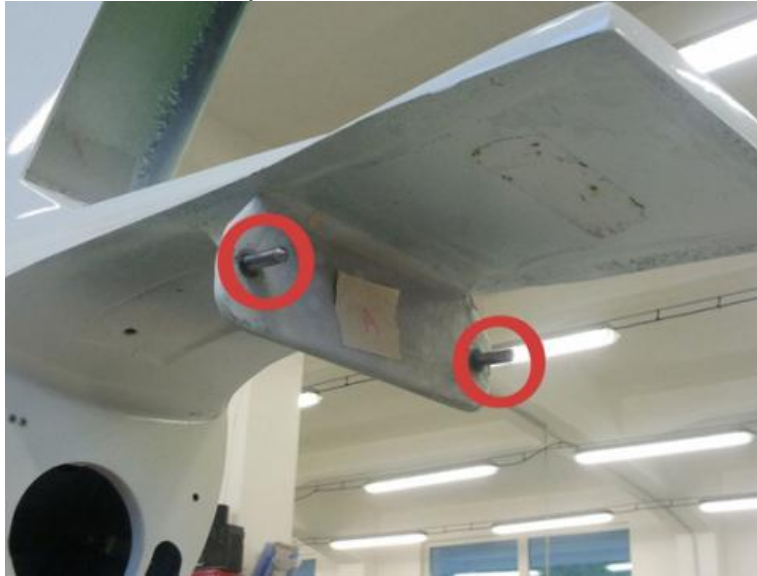
Figure 1

Reports from the field indicate that trapped moisture may accumulate in the interior of the alignment fitting and possibly cause corrosion on any exposed metal surface. Aircraft that are located near coastal salt waters, whether stored inside or parked outside may be more susceptible to corrosion of any non-protected metal surfaces.

At the next annual condition inspection, remove the horizontal stabilizer and inspect the connection pins (Figure 1) to assure that there is no hidden corrosion. Some aircraft may have an extensive amount of silicone adhesive in the contact surface between the lower face of the beaver tail extension both ahead and aft of the alignment pins. Safety wire or dental floss may be used to break the silicone bond to these surfaces for removal of the upper face of the horizontal stabilizer.
