SAFETY ALERT

StingSport Nose Gear Strut Inspection

AFFECTED AIRCRAFT: TL-Ultralight; TL-2000 StingSport

NOTICE ID: TL091507-Rev1

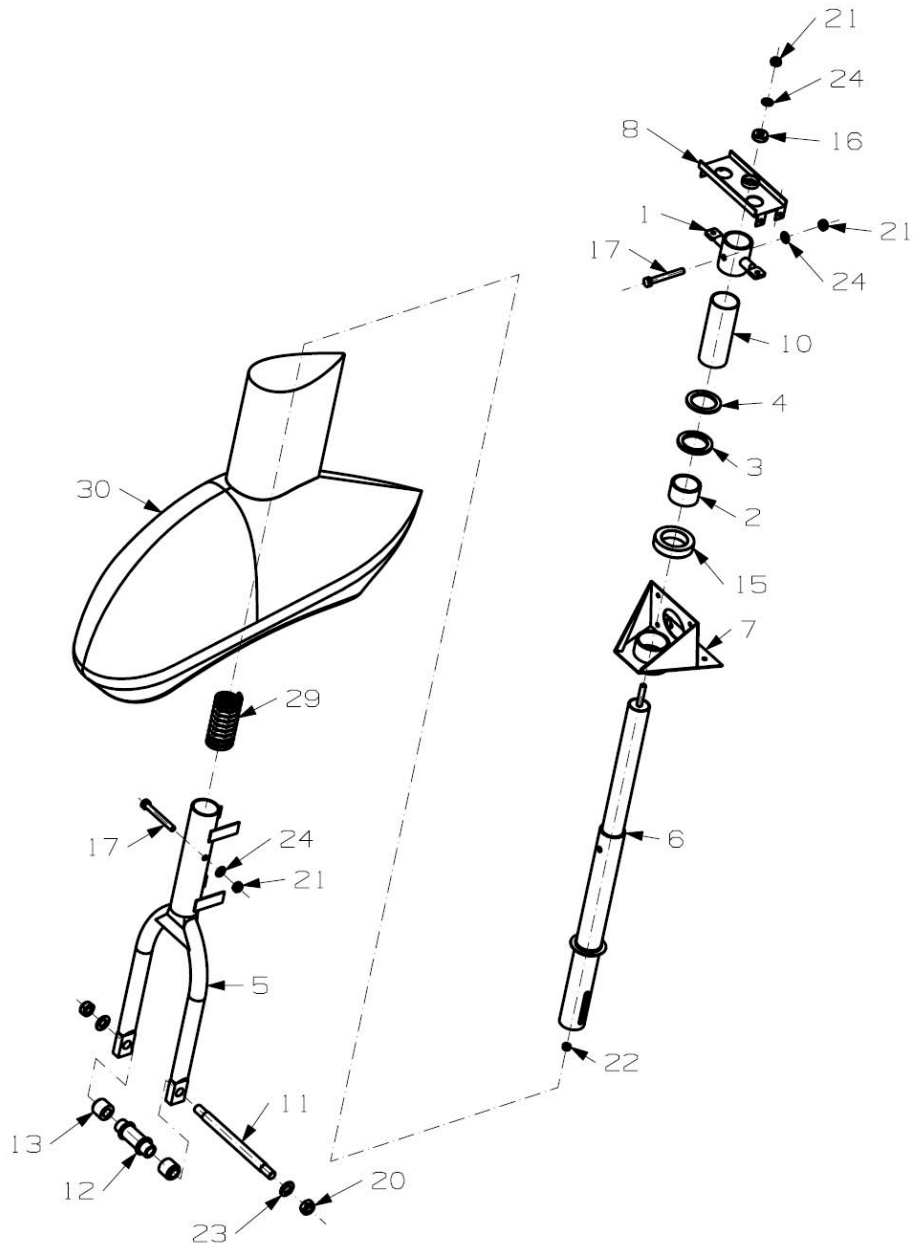
Reason for Issuance: Field report of a nose gear strut failure subsequent to the discovery of radiating cracks at ends of the nose gear strut retaining bolt slot found during the previous annual condition inspection but not corrected.

Description of the assembly: The lower nose wheel fork (Item 5 in the illustration below) and wheel/tire assembly attaches to the upper nose gear strut-tube (Item 6 in the illustration below) by a single bolt (Item 17 in the illustration below). This bolt aligns the upper and lower nose gear tubes and retains the spring (Item 29 in the illustration below) which is compressed from above by the lower end of the upper nose gear strut and contained by the lower nose gear yoke tube.

The bolt functions to retain the alignment of the centerline of the lower nose wheel fork (therefore the nose wheel/tire assembly) and the upper nose gear strut (item 6 in the illustration below) which is connected to the push rods attached to the rudder pedals.

1. The area of this inspection is primarily the upper and lower portions of the machined slot in the lower part of the strut. This slot should be examined in detail while on the aircraft after removal of the lower nose gear fork and wheel assembly. Replace the nose gear strut if there is any sign of cracks radiating from the slot or other indications of metal stress.
2. Also inspect the top edge of the nose wheel fork (Item 5 in the illustration below) as it exits the top of the nose wheel fairing (Item 30 in the illustration below). This steel tube should have vertical straight edges and should be round and concentric. There should not be signs of metal stress such as "belled-out" edges or an elliptical shape at the top of this tube. Replace the nose wheel fork if signs of metal stress are present.
3. Make a log entry of this inspection in the aircraft records.
