TL-ULTRALIGHT STINGSPOURT

How To Adjust The Trim Tabs

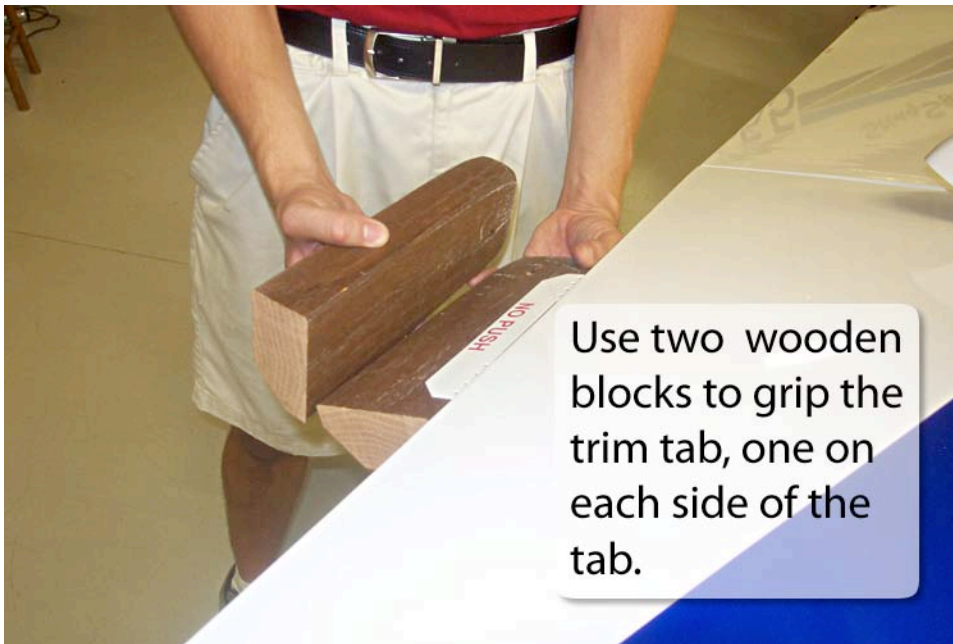
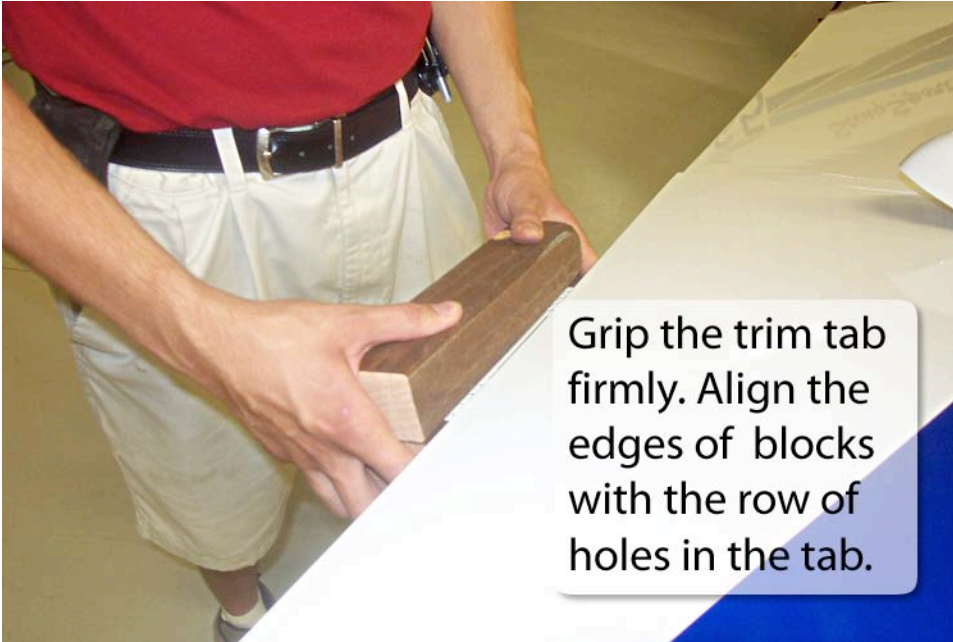
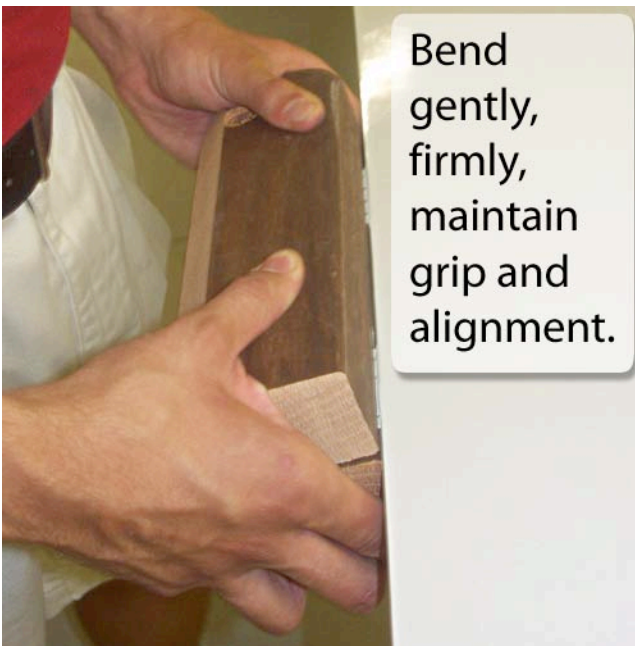
Trim tabs are located on the right aileron and the rudder of the TL 2000 StingSport. Adjusting one of the trim tabs is accomplished by bending the tab in the desired direction is a simple procedure, but should be done carefully to insure that the bend is uniform.

Bending the aileron trim tab is illustrated in the photo series below.

Small adjustments should be made, followed by flight testing. Repeat if necessary.
